# Accidental Overexposure of Radiotherapy Patients in Białystok

ACCIDENTAL OVEREXPOSURE  
OF RADIOTHERAPY PATIENTS  
IN BIAŁYSTOK

© IAEA, 2004

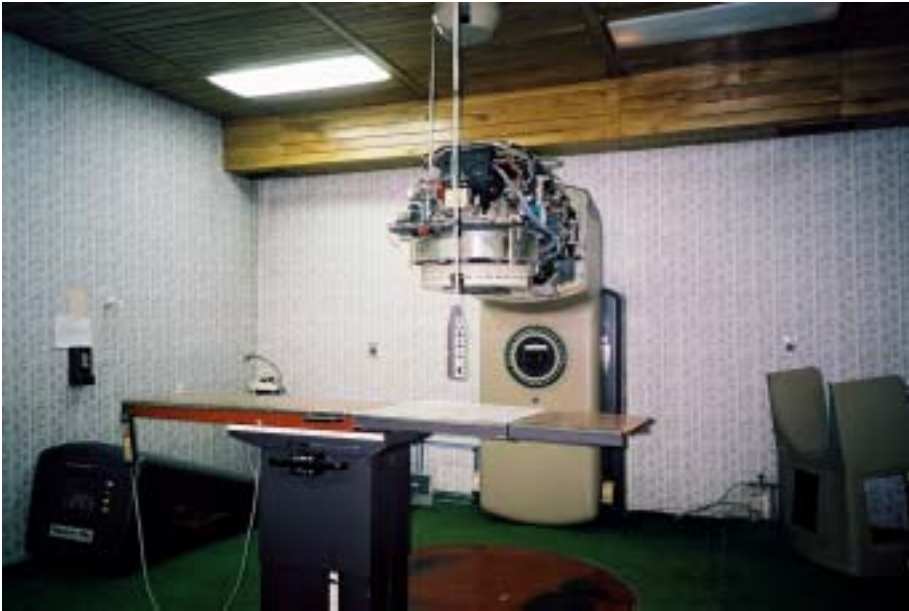
*FIG. 1. The NEPTUN 10P<sup>®</sup> accelerator. The irradiation head was opened when measurements were being carried out during the IAEA mission.*

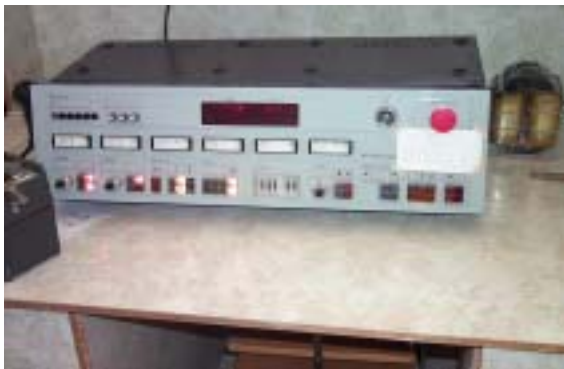
The NEPTUN 10P<sup>®</sup> requires a starting procedure to be followed in order to be able to initiate an irradiation process. The procedure requires the pressing of a series of keys in sequence, each of which initiates a check or control function. It is necessary to complete one series in order to be allowed to proceed to the next step. Satisfactory completion of each stage is indicated by a green light. Figure 2 illustrates the relevant series of keys on the control panel.

*FIG. 2. Photograph of the control panel of the NEPTUN 10P<sup>®</sup> showing the series of keys relevant to this event.*

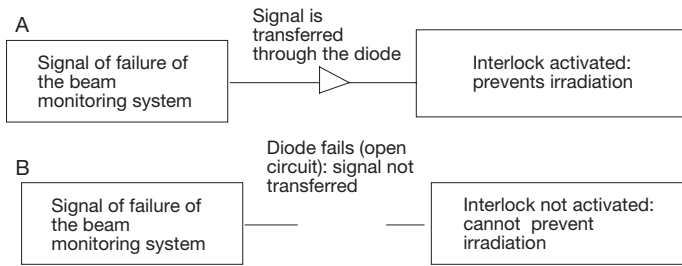
The accidental overexposure in Białystok demonstrated that two faults in two circuits could occur at the same time and lead to machine operation with an ineffective beam monitoring system. Moreover, the probability of such a double fault occurring was increased by the fact that an inoperative interlock (the diode) went unnoticed until the second fault occurred in the beam monitoring system. In this situation, the interlock could allow the start sequence to progress, even if a second fault, a defective fuse in the power supply to the dose monitoring systems, rendered the system ineffective and led to the filament current being driven to its maximum.

Function of diode D 29:

- A: Diode working properly
- B: Diode disabled (open circuit)

*FIG. 3. Representation of the failure of the D29 diode.*

- (a) *Design of the monitoring system.* If, under any fault conditions, the equipment can deliver an absorbed dose rate at normal treatment distance of more than ten times the maximum specified in the technical description, a radiation beam monitoring device, which shall use a circuit independent of the dose rate monitoring system, shall be incorporated on the patient side of the radiation beam distribution system. This shall limit the excess absorbed dose at any point in the radiation field to less than 4 Gy (Section 29.1.3). NOTE: In equipment capable of producing both X radiation and electron radiation, the termination of irradiation may need to be completed before the generation of the next pulse of radiation.
- (b) *Design of safety interlocks.* Equipment shall be so designed and manufactured that, even in single fault condition, no safety hazard exists (Section 52).

- (c) *Examination of safety interlocks.* The safety interlocks need to be examined to ensure fail-safe conditions, i.e. failure of any element which could affect the correct function of any interlock shall terminate irradiation. Section 29.1.3 further establishes that "...means to protect a possible overdose due to an absorbed dose rate more than twice the specified maximum, and limit the excess absorbed dose to less than 4 Gy ... shall be tested between, or prior to, irradiations for their ability to function." In other words, the interlocks need to be tested before each new treatment. This would prevent an ineffective interlock from going unnoticed.

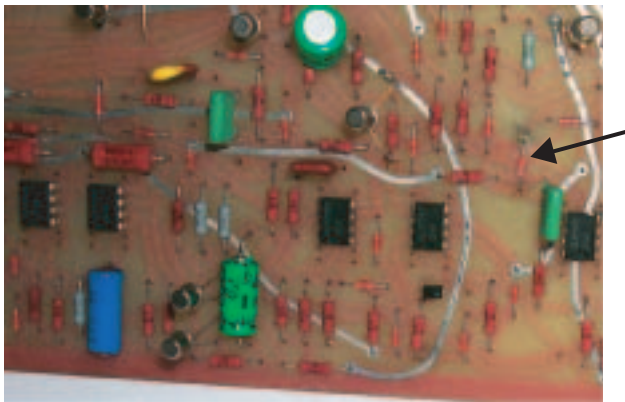
*FIG. 4. Photograph of the electronic board and the D29 diode.*

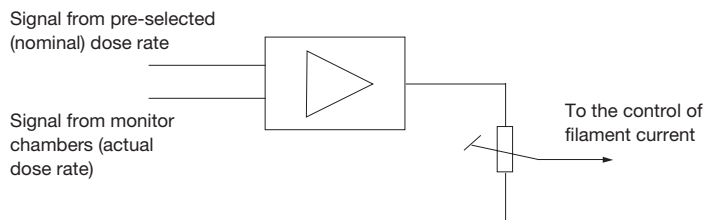
FIG. 5. Limitation of filament current by means of a potentiometer.

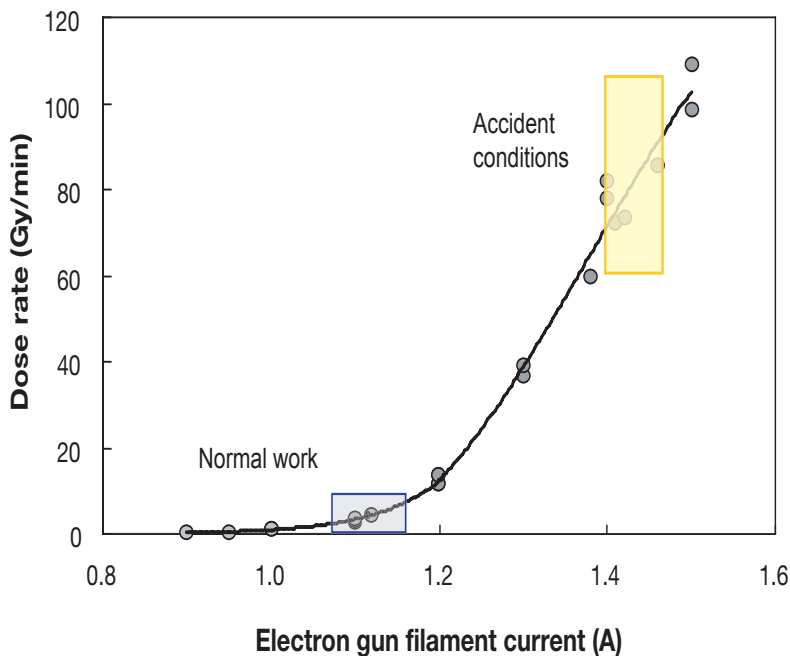
In order to reproduce the condition of the machine after the accident, the machine settings were based on notes of the dosimetry measurements made by the local medical physics staff at the time, i.e. preselected dose rate of 300 MU/min, filament current of the electron gun at 1.40–1.46 A and the dose rate indicator on the accelerator console at approximately 100 MU/min.

FIG. 6. The output of the 8 MeV electron beam of the NEPTUN 10P<sup>®</sup> in conditions close to the treatment prescription for the affected patients ( $SSD = 100$  cm, field size  $14$  cm  $\times$   $12$  cm,  $d_{max} = 1.9$  cm) as a function of the current in the primary of the transformer that provides AC to the filament of the electron gun.

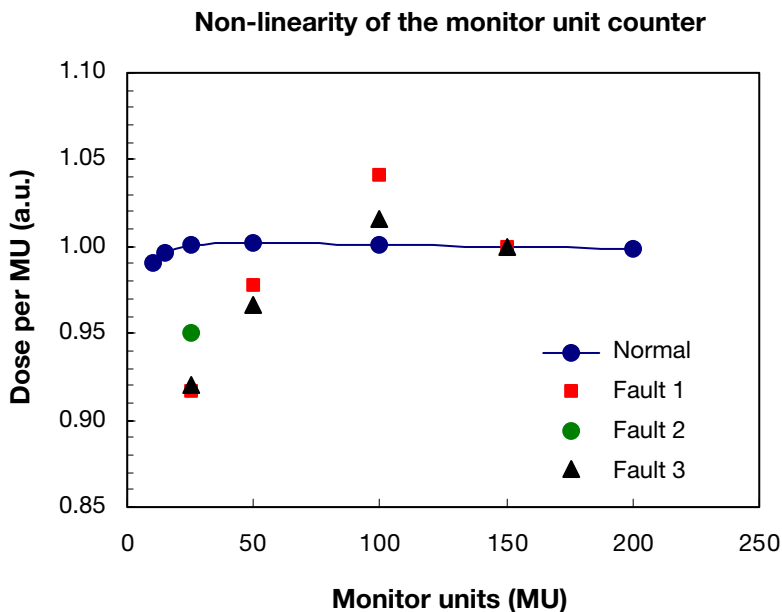
Owing to the limited range of their dosimetry system, the measurements made by the local physicists were performed at 25 MU instead of 150 MU as was prescribed for the treatment of the affected patients. The dose values were then extrapolated from 25 MU to 150 MU. This value has a significant uncertainty owing to the errors in the NEPTUN 10P<sup>®</sup> MU counter. These errors were caused by an incorrect signal from the monitoring chambers system, which was operating with a greatly reduced polarization voltage. The tests of the MU counter were performed by the IAEA medical physics and radiation safety team using three different machines of the NEPTUN type located at the Oncology Hospital in Łódź, at the manufacturer’s site in Świerk and at the BOC.

FIG. 7. The dose–response non-linearity of the NEPTUN 10P<sup>®</sup> MU counter caused by the incorrect signal from the monitoring system operating with a greatly reduced polarization voltage. The solid line corresponds to normal working conditions (the normal values were measured in Łódź), whereas the scattered data points correspond to the fault conditions (Fault 1 and Fault 2 were measured in Białystok and Fault 3 in Świerk). The measured doses per MU for the different MU numbers pre-set at the console are normalized to the dose per MU at 150 MU.

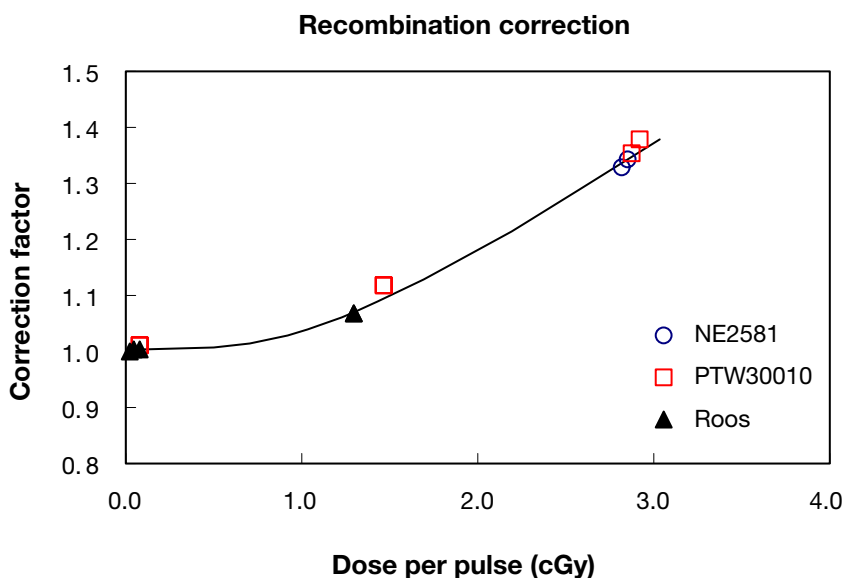
FIG. 8. Ionization chamber recombination corrections measured with a two-voltage technique for the different values of doses per pulse. Measurements performed on three NEPTUN 10P<sup>®</sup> machines in Łódź, Białystok and Świerk.

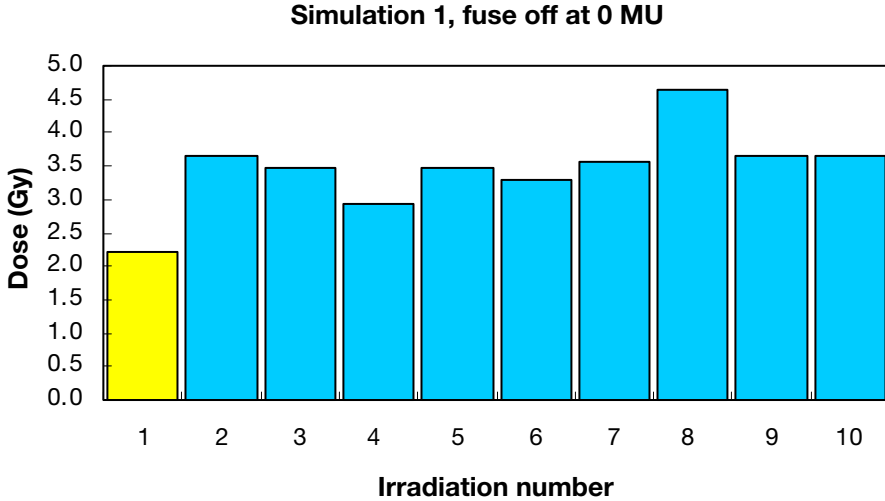
The first test consisted of simulating a fuse break at the beginning of a treatment session so that the voltage of the accelerator monitoring system decreased during the course of each treatment: each measurement started with the full voltage (300 V) being applied to the monitoring chambers and ended

FIG. 9. Doses from 8 MeV electron beam to a hypothetical first ‘patient’ irradiated after shut-off of the accelerator; the fuse breaks at the beginning of the treatment session so that the voltage of the accelerator monitoring system is greatly reduced. The yellow bar indicates normal treatment conditions with an operational monitoring chamber. The absorbed dose to water was measured with a Roos chamber and a setting of 150 MU selected at the NEPTUN 10P<sup>®</sup> console (SSD = 100 cm, field size 14 cm × 12 cm,  $d_{max} = 1.9$  cm in water). The filament current was set at different values that ranged between 1.10 A and 1.42 A.

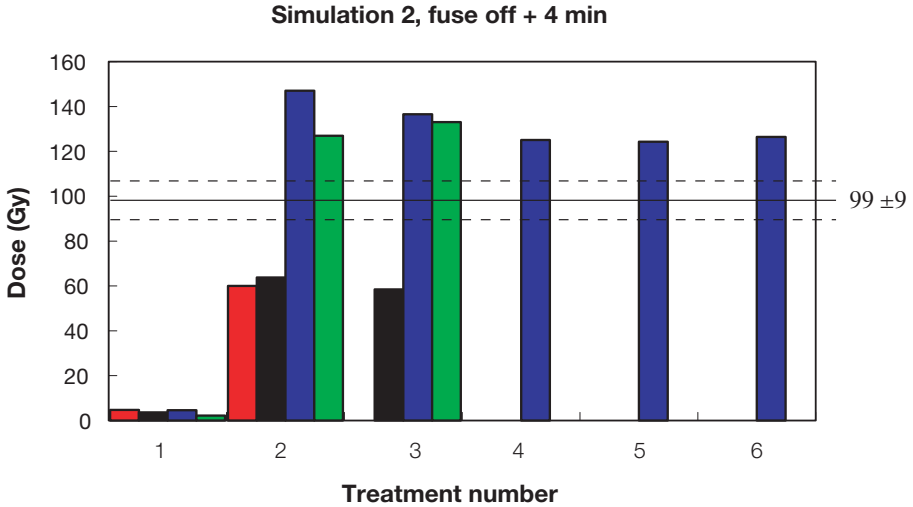
If the machine timer was set at 1.5 min, as remembered by the local staff, and the irradiation stopped after 1.5 min and before completion of the preset 150 MU, the doses in treatments 2–6 would be reduced to approximately 25 Gy at the 1.22 A filament limit and to 100–110 Gy at the 1.46–1.48 A limit. The corresponding dose rates displayed on the machine console were 80–110 MU/min.

FIG. 10. Simulation of doses to patients after the fuse break. The groups numbered 1 to 6 represent consecutive patient treatments, each one resumed following a 4 min interval. Different colours correspond to different settings for limiting the filament current in the electron gun: 1.22 A (red and black bars), 1.46–1.48 A (blue and green bars). Absorbed dose to water was measured in a water phantom with a Roos chamber at 150 MU, SSD = 100 cm, field size 14 cm × 12 cm,  $d_{max} = 1.9$  cm. The horizontal line indicates the dose measured by the local physicists on the day of the accident.

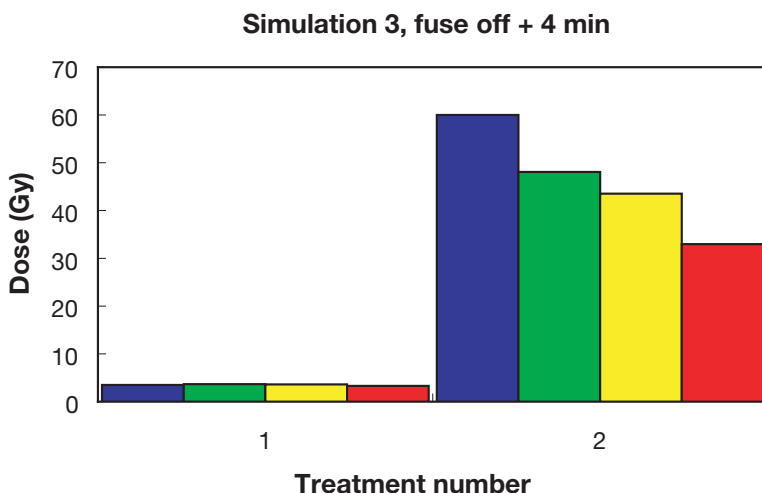
While operating under the simulated fault conditions and within the selected range of parameter settings, the NEPTUN 10P<sup>®</sup> may deliver doses at the depth,  $d_{max}$ , of the order of 30–60 Gy per 150 MU (Fig. 11). These doses may result from resetting the limiting filament current from 1.15 A (just above

*FIG. 11. Simulation of doses to patients after a fuse break. Measurements for group 1 were taken at the fuse break; group 2 corresponds to the subsequent treatment, started after a 4 min interval. The limiting current for the electron gun filament was manually set to 1.22 A (normal setting, blue bar), 1.20 A, 1.18 A and 1.15 A (green, yellow and red bars, respectively). The absorbed dose was measured in a water phantom with a Roos chamber at 150 MU, SSD = 100 cm, field size 14 cm × 12 cm,  $d_{max} = 1.9$  cm.*
